# **THE EATONTOWN SEWERAGE AUTHORITY**

## **MAINTENANCE REPORT**

### **Report for October 2025 Activities**

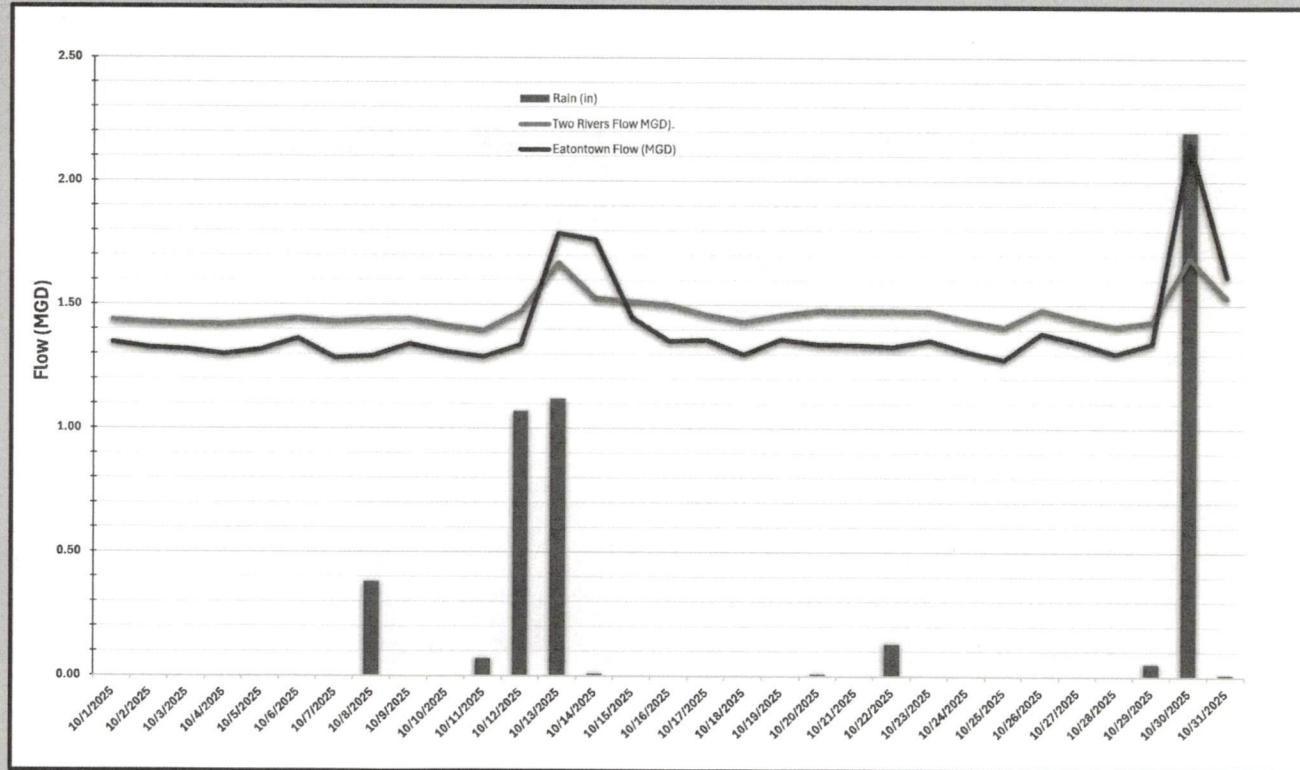
## Flow Comparison Chart - Two Rivers Flow v. Eatontown October 2025

Date	Eatontown Flow (MGD)	Two Rivers Flow (MGD)	Rain (In)
10/1/2025	1.347	1.438	0.00
10/2/2025	1.326	1.428	0.00
10/3/2025	1.318	1.423	0.00
10/4/2025	1.300	1.422	0.00
10/5/2025	1.317	1.432	0.00
10/6/2025	1.363	1.446	0.00
10/7/2025	1.285	1.432	0.00
10/8/2025	1.292	1.441	0.38
10/9/2025	1.341	1.443	0.00
10/10/2025	1.310	1.416	0.00
10/11/2025	1.289	1.396	0.07
10/12/2025	1.338	1.473	1.07
10/13/2025	1.790	1.671	1.12
10/14/2025	1.762	1.527	0.01
10/15/2025	1.446	1.514	0.00
10/16/2025	1.353	1.501	0.00
10/17/2025	1.358	1.460	0.00
10/18/2025	1.299	1.432	0.00
10/19/2025	1.360	1.459	0.00
10/20/2025	1.341	1.477	0.01
10/21/2025	1.338	1.476	0.00
10/22/2025	1.330	1.476	0.13
10/23/2025	1.355	1.474	0.00
10/24/2025	1.310	1.437	0.00
10/25/2025	1.278	1.410	0.00
10/26/2025	1.385	1.481	0.00
10/27/2025	1.348	1.442	0.00
10/28/2025	1.304	1.414	0.00
10/29/2025	1.346	1.434	0.05
10/30/2025	2.155	1.691	2.20
10/31/2025	1.615	1.530	0.01
<b>Total</b>	<b>43.299</b>	<b>45.496</b>	<b>5.050</b>
